# On aging problem of glass Resistive Plate Chambers

S.S.Bhide, V.M.Datar, S.D.Kalmani, N.K.Mondal, L.M.Pant, B.Satyanarayana\*, R.R.Shinde  
India-based Neutrino Observatory (INO) Collaboration, INDIA  
\*E-mail: bsn@tifr.res.in

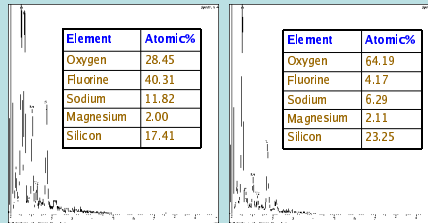
Fig. 9 Element analysis results of damaged electrode and raw glass

Element analysis was also performed again both on damaged electrode and raw glass sample, results of which are shown in Fig 9 and the inset tables. The structures shown in the AFM and SEM scans were found to be rich in Fluorine confirming the reasoning that Freon (R134a) gas contaminated with moisture forms Hydro Fluoride (HF), which actually damages the RPC.
